## Physical and Anthropogenic Factors of Flood Disaster: The case of Akurana Urban Area, Kandy District, Sri Lanka

### Abstract

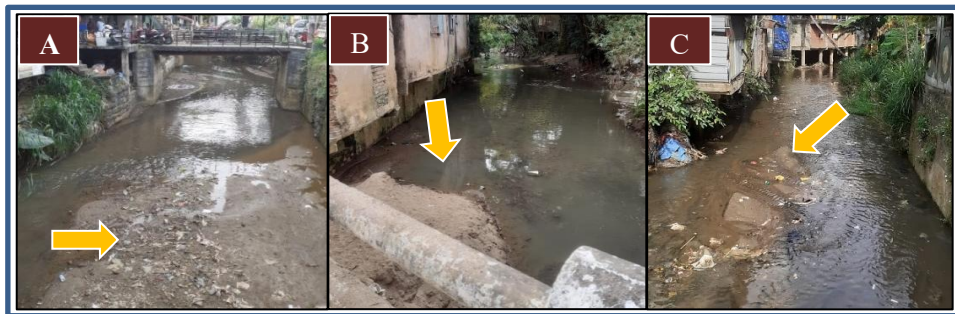
Figure 6: Deposits in the Riverbeds A-C, (Field Survey, 2023/24)

Increased sedimentation from the river networks of the Pinga Oya watershed has also led to more flooding in the study area. Since the area consists predominantly of soil types such as IBL - Immature Brown Loam Soil, RBL - Reddish Brown Latosol, and Lithosols, which are types that are easily eroded they are washed out of upland areas along the slope lands during rainy spells. Eroded soil settles as silt in riverbeds, causing rivers to become clogged. Thus, increased sediments contribute to sediment accumulation on riverbeds, reducing river depth and causing sediment pollution, which has become a significant environmental problem in the region from an ecological perspective (Figure 6). Moreover, the sediment deposits alter the river's flow patterns, reducing its width and depth, and also restrict channel flow, resulting in frequent flooding.

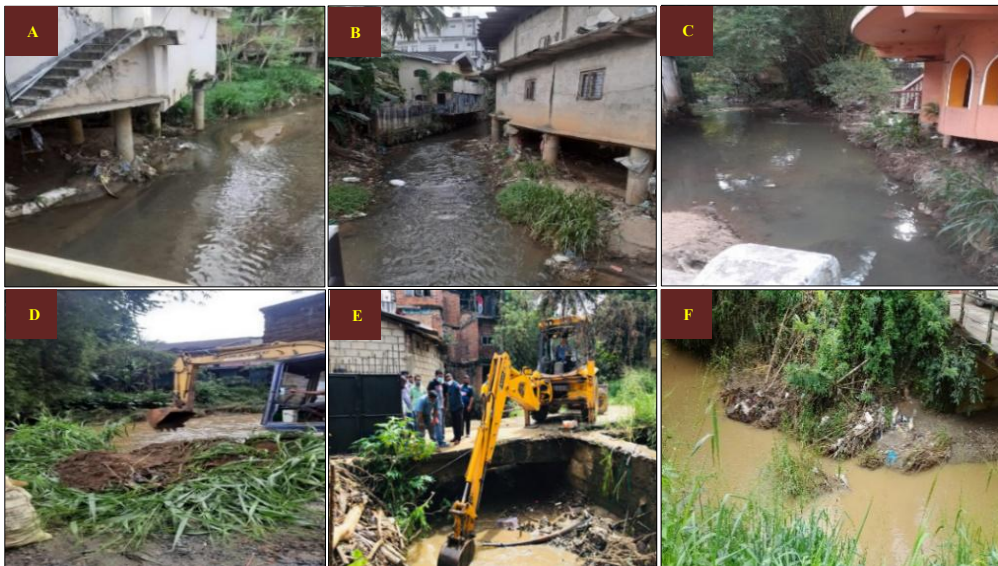
Figure 16: Improper Waste Disposal - Water Pollution in the Study Area, A- C Field Survey, 2023/24, D-F Obtained from DS Office, Akurana)

The results reveal that inadequate and improper solid waste management, sewage discharge into the Pinga Oya, and poor drainage systems also contribute to urban flooding. The growth of built-up area is accompanied by rapid urban population growth, resulting in increased waste generation, including domestic, commercial, and industrial waste. According to the records of each Divisional Secretariat, approximately 1,500–1,600 metric tons of garbage are collected annually. Of these, approximately only four metric tons are recycled.

The consumption culture, which consistently produces more solid waste, exacerbates the water pollution crisis in Pinga Oya, particularly in urban settings (Mahees et al., 2011). Thus, higher waste generation and improper solid waste management practices have emerged as a serious concern in environmental contexts. The unlawful dumping of solid waste into Pinga Oya and Kasawatha Oya by residents is a serious issue that is consistently reported in the study area (KII, 2023). As a result, the riverbed is deposited with waste dumped into the river and with sediments from the Pinga Oya watershed (Figure 16). It has a significant impact on water quality, contributing to drain blockage and exacerbating flooding in the area (KII, 2023). During the rainy season, urban surfaces, solid waste, and poor drainage cause water stagnation. This situation increases the risk of flooding in the shallow, narrow river channel.
